VALLIS TRADE ASSURANCE SERVICES (VTAS)

PHOTOGRAPHIC REPORT

ABIDJAN – IVORY COAST

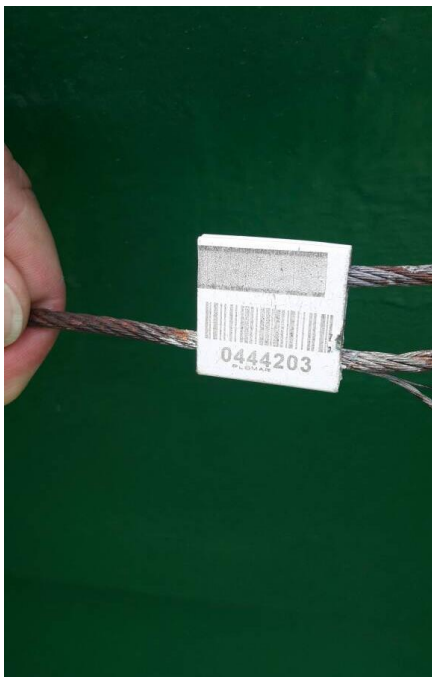
- 2.3 Seal inspections of Holds 1 and 4 were carried out at 09:05; all seals were found to be intact in accordance with the hold Sealing Certificates and Unsealing Certificates were issued accordingly. See photos 3 to 8.

3. Hold 4 – Aft Access – Seal intact.

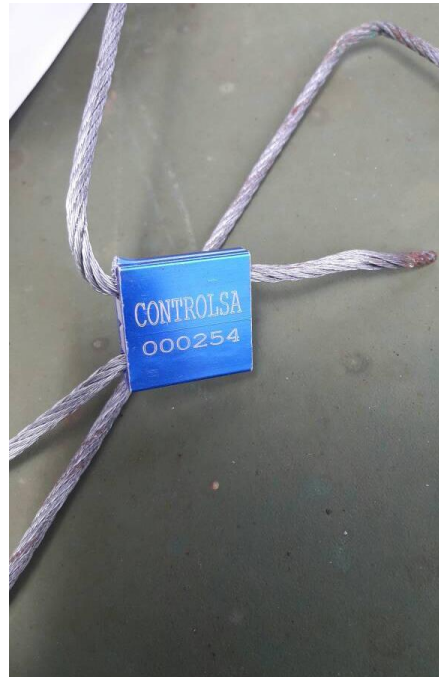
4. Hold 4 – Main Hold – Seal intact.

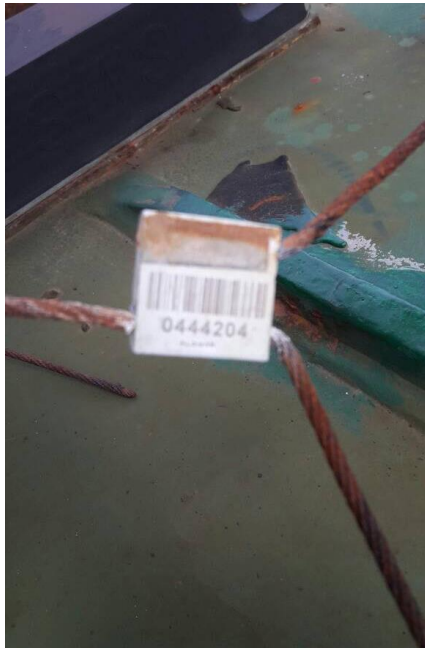
5. Hold 1 – Forward Access – Seal intact.

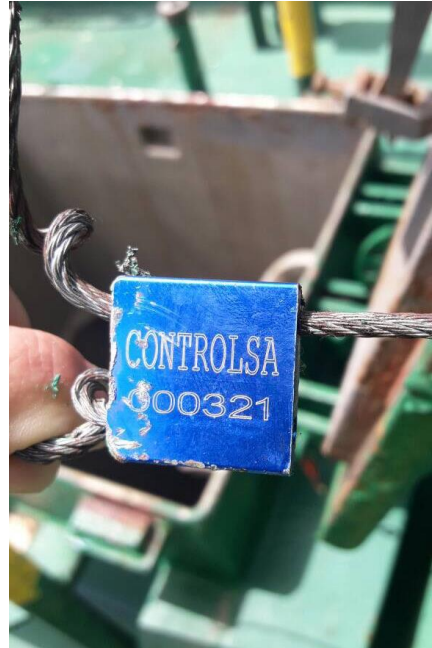
6. Hold 1 – Main Hold – Seal Intact.

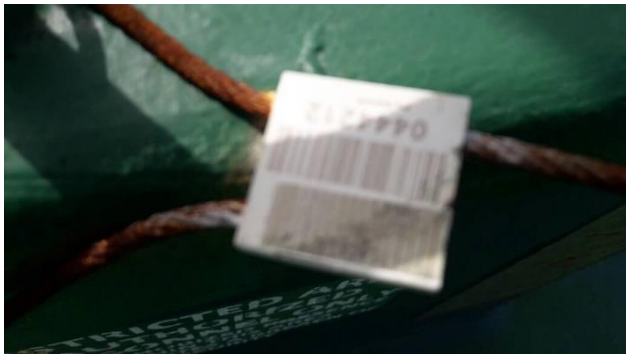
7. Hold 4 – Forward Access – Seal Intact.

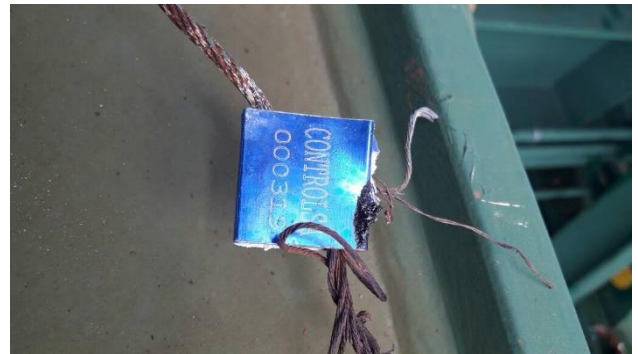
8. Hold 1 – Main Access – Seal Intact.

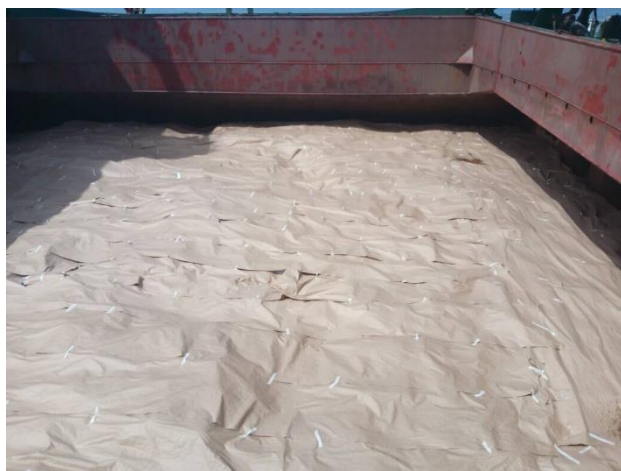
- 2.4 Cargo holds were opened from 09:54, starting with Hold 4. See photos 9 to 12.
- 2.5 Pre-discharge inspections were conducted and the cargo was found to be in good condition with no signs of water ingress, damage to the cargo or contamination. See photos 13 to 15.

13. Cargo condition on arrival in Abidjan. Paper covering intact and no sign of water damage.

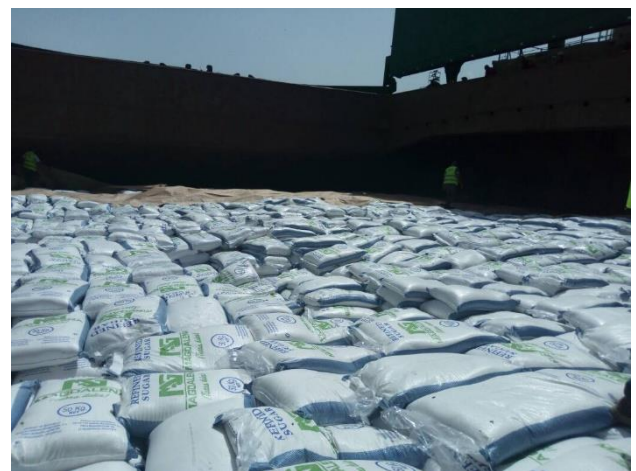
14. Cargo condition on opening hold. Bags appear in good condition. No visual signs of damage.

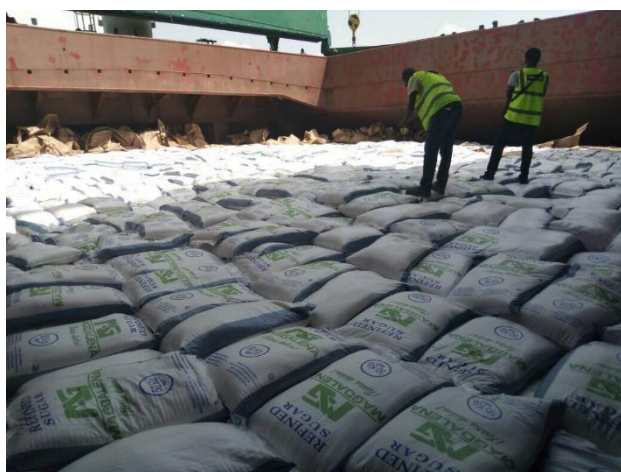
15. Further view of cargo in the hold. No signs of damage.
